Test report

Alternating climate test at bullet proof window

for PG Products Indústria e Comércio de Vidros Ltda

19.04.2006

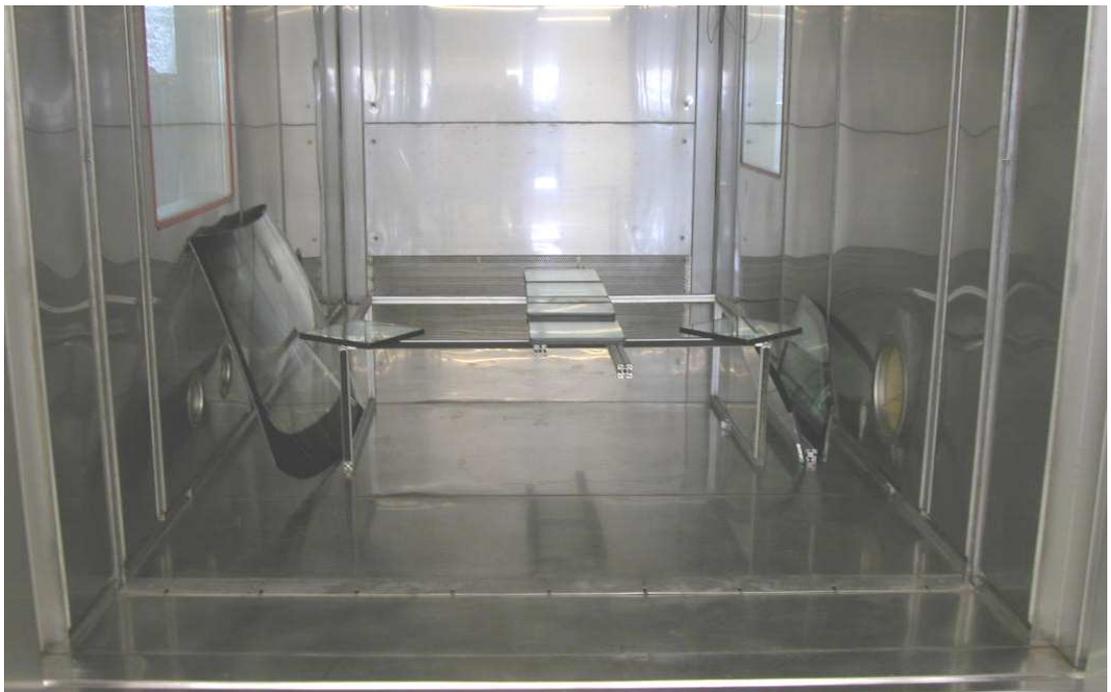
Picture 1: test set up in climatic chamber

The windows were fixture in installation position in the climatic chamber.

We proofed the test parts before beginning the test. Afterwards the windows were fixture in installation position in the climatic chamber. Proof the test parts after test.

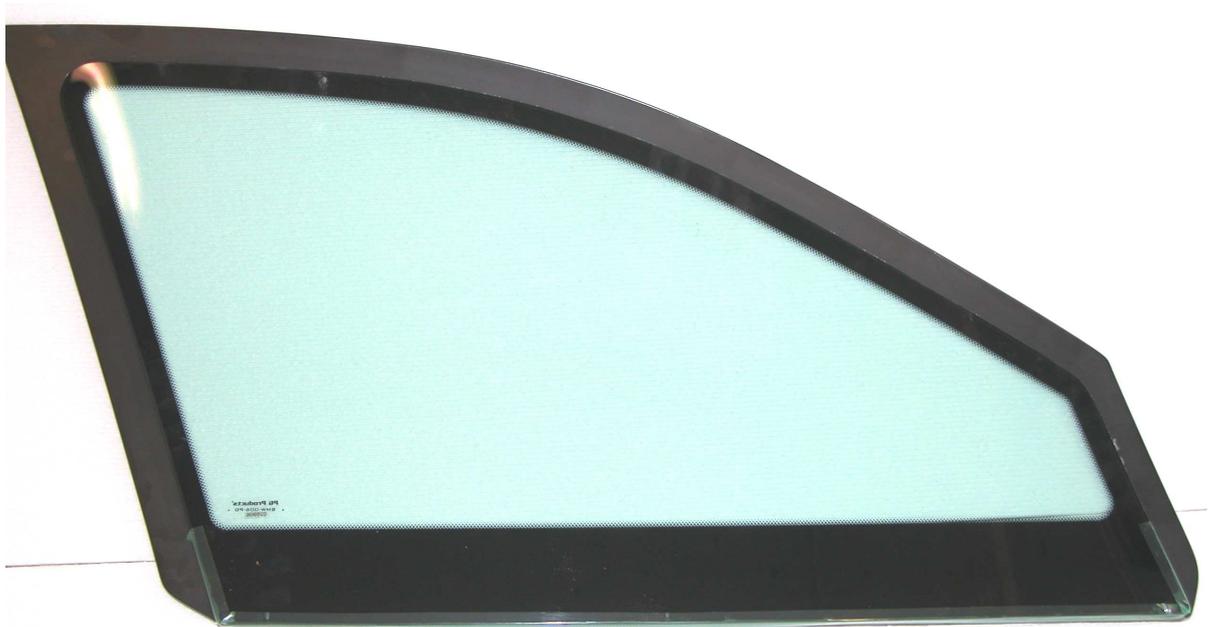
Picture 2: left front door - SG2B4- sample for ballistic test, Code PDEBMW5 after Test

It was no damages and discoloration at the test parts. The test parts are OK.

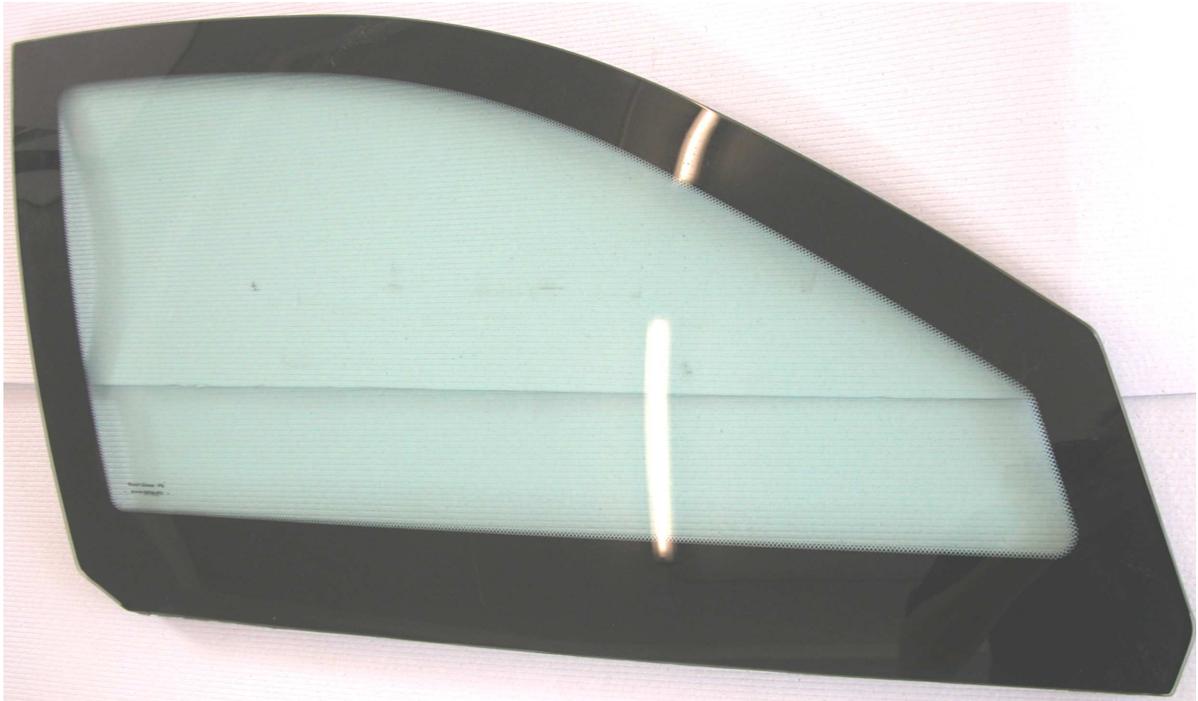
Picture 3: right front door - B4- sample for ballistic test , Code PDDBMW5 after test

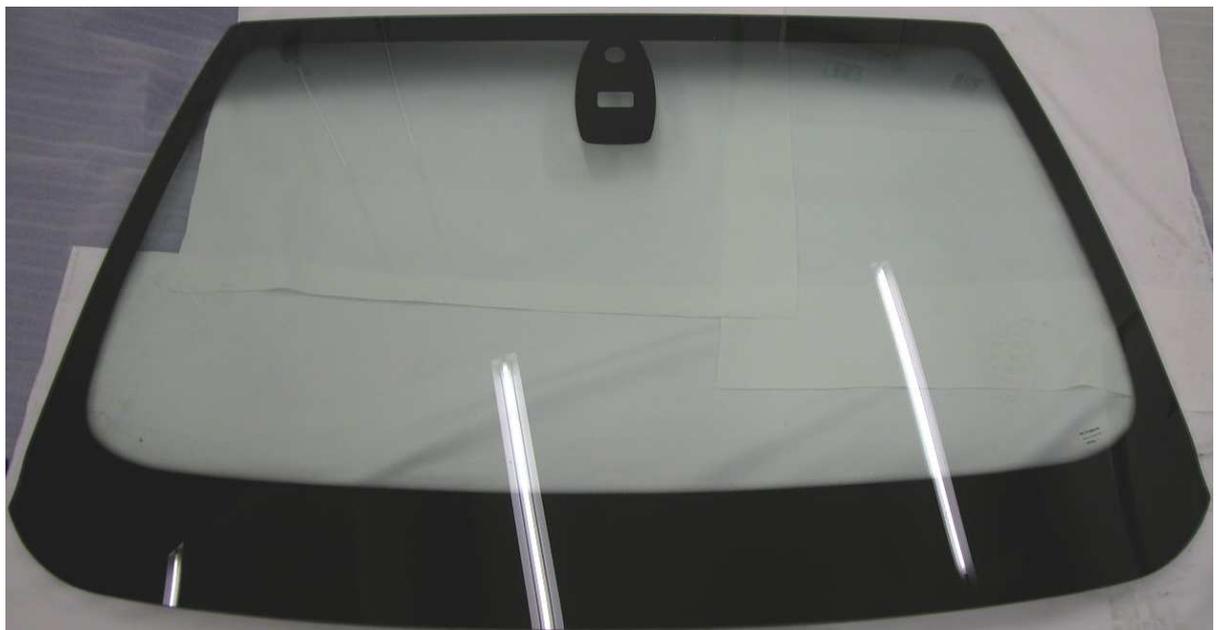
Picture 4: windshield- B4- sample for ballistic test, Code PBBMW5 after Test

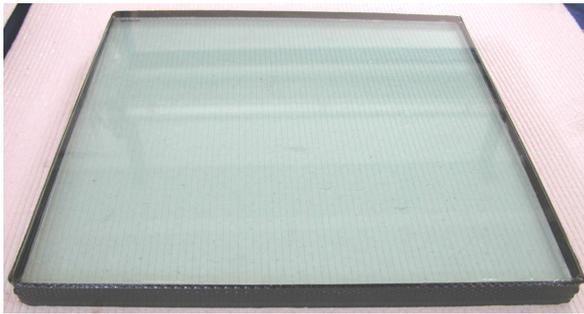
Picture 5: B4- 300 Code B4 300 after test

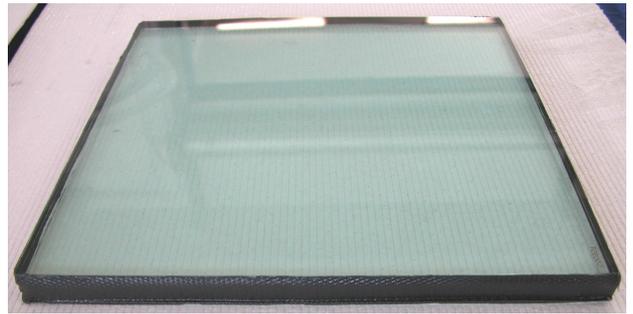
Picture 6: B4- 300 Code B4 300 after test

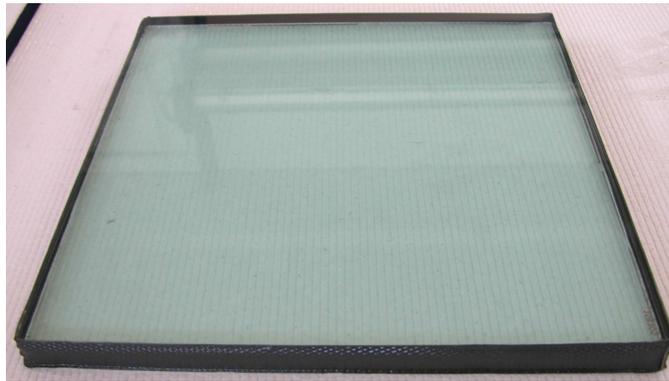
Picture 7: B4- 300 Code B4 300 after Test

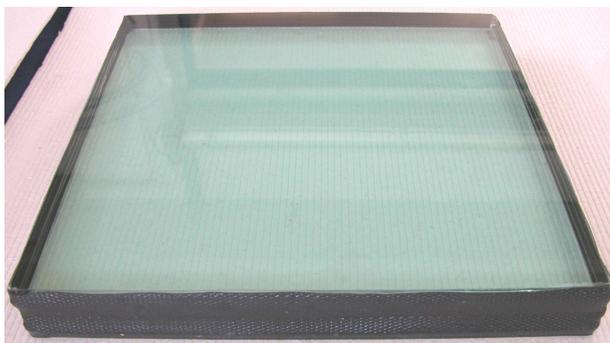
Picture 8: B6- 300 Code B6 300 after Test

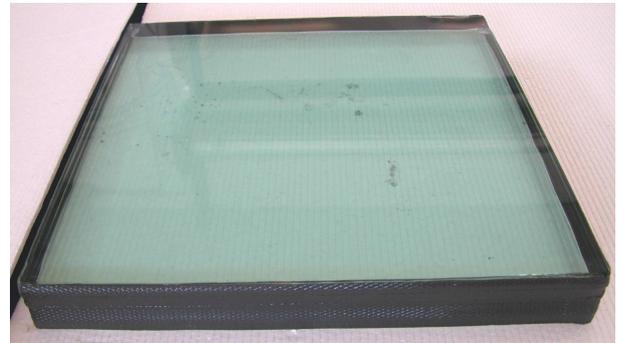
Picture 9: B6- 300 Code B6 300 after Test

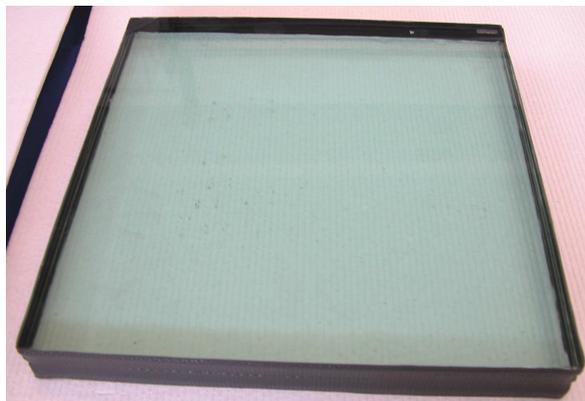
Picture 10: B6- 300 Code B6 300 after Test

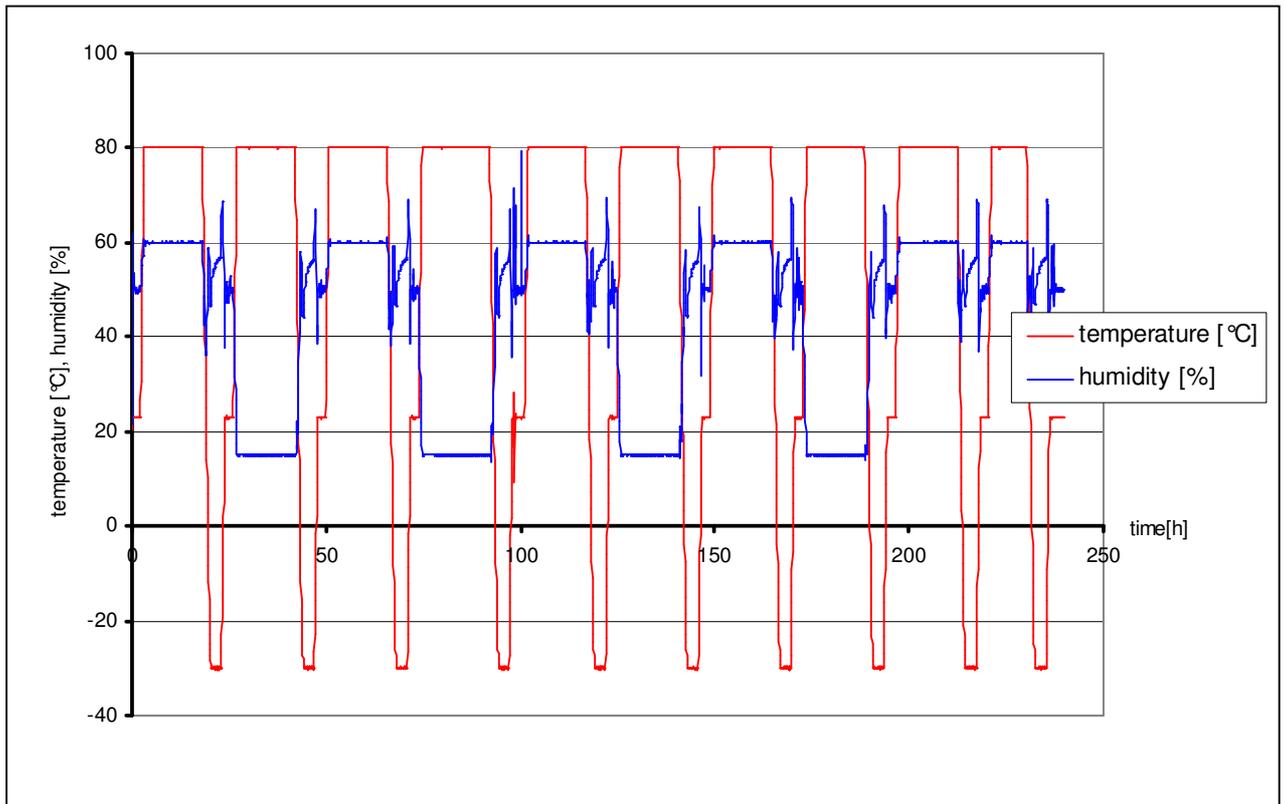
Diagram 1: climatic chamber recording
